# Preservation Master Plan

*Riverside Cemetery  
Sunderland, Massachusetts*

**Martha Lyon Landscape Architecture, LLC**  
*313 Elm Street  
Northampton, MA 01060  
413-586-4178  
[www.marthalyon.com](http://www.marthalyon.com)*

**Monument Conservation Collaborative, LLC**  
*P. O. Box 541  
Norfolk, CT 06058  
860-309-9491  
[www.mcc-monument-conservation.com](http://www.mcc-monument-conservation.com)*

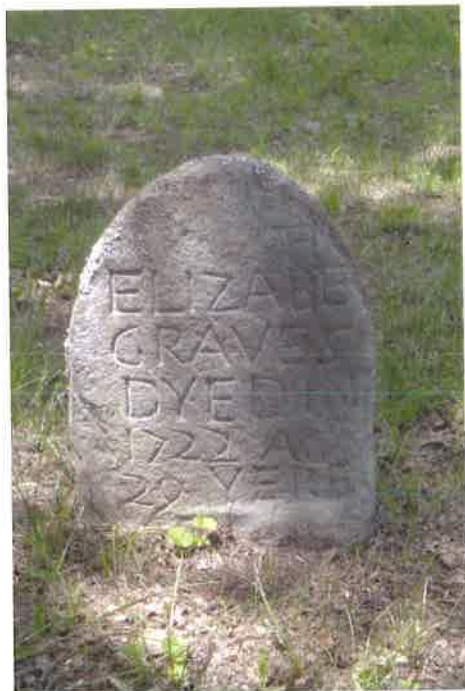
*The first known burial at Riverside Cemetery was of Elizabeth Graves, who died in 1722. The portal-shaped marker is carved from local stone.*

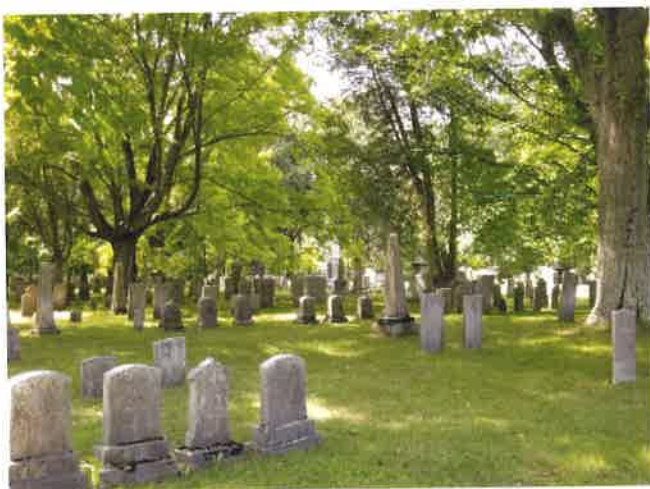
*Several Victorian era “stele” monuments dot the mid-19<sup>th</sup> century sections of Riverside.*

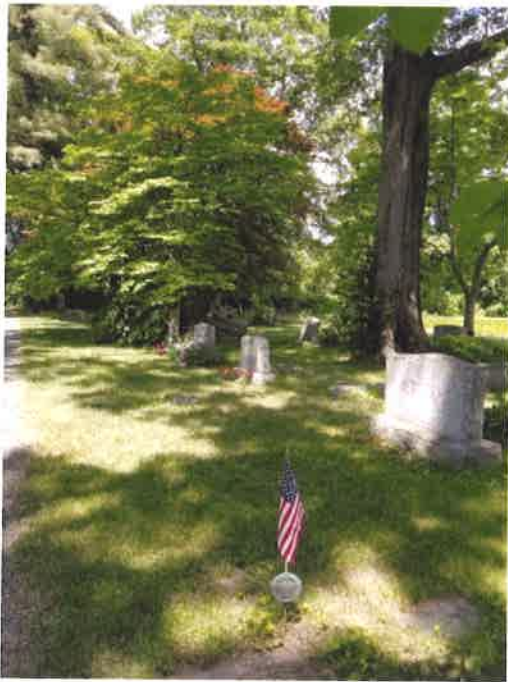
*The Northernmost section, added in 1887, contains modern style markers – 30" height granite stones at the graves of two persons.*

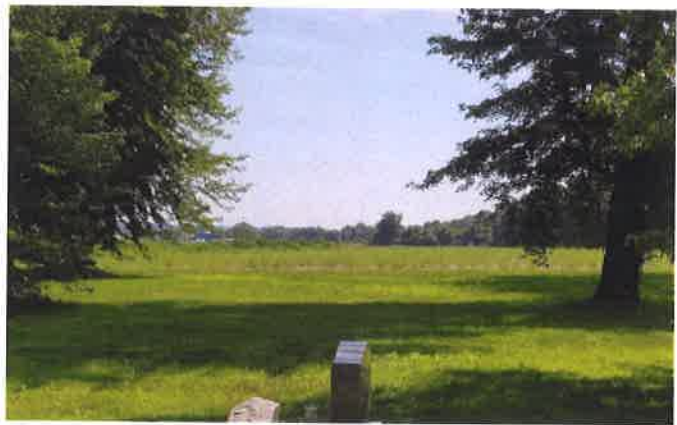
*The southernmost section, added in the 1990s, has been plotted but does not contain a roadway or paths.*

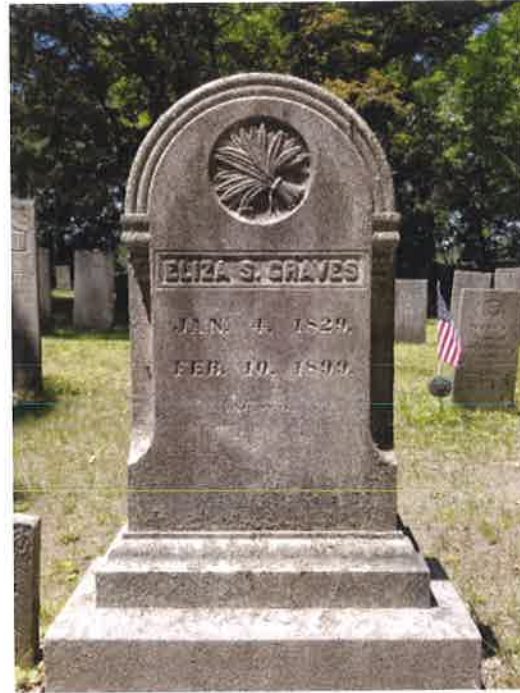
*The marble marker of Eliza Graves typifies the Victorian style of gravestone, with Classical architectural detailing and a wheat shaft inscribed in the tympanum (arch).*

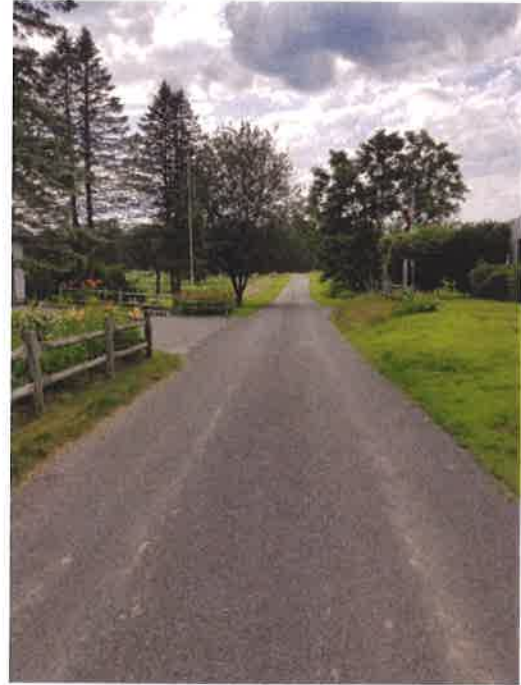
*"Cemetery Road" became an official town way in 1875, one rod wide and approximately 800 feet long, connecting Main Street to the cemetery.*

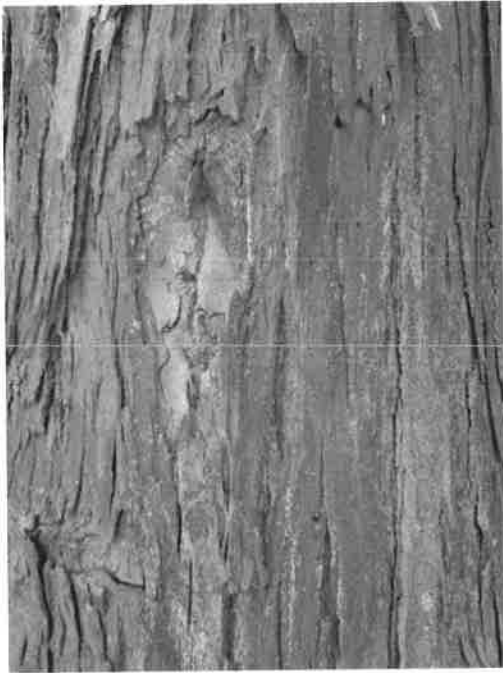
A mature horse chestnut tree stands along the west edge, one of many old trees within the cemetery.

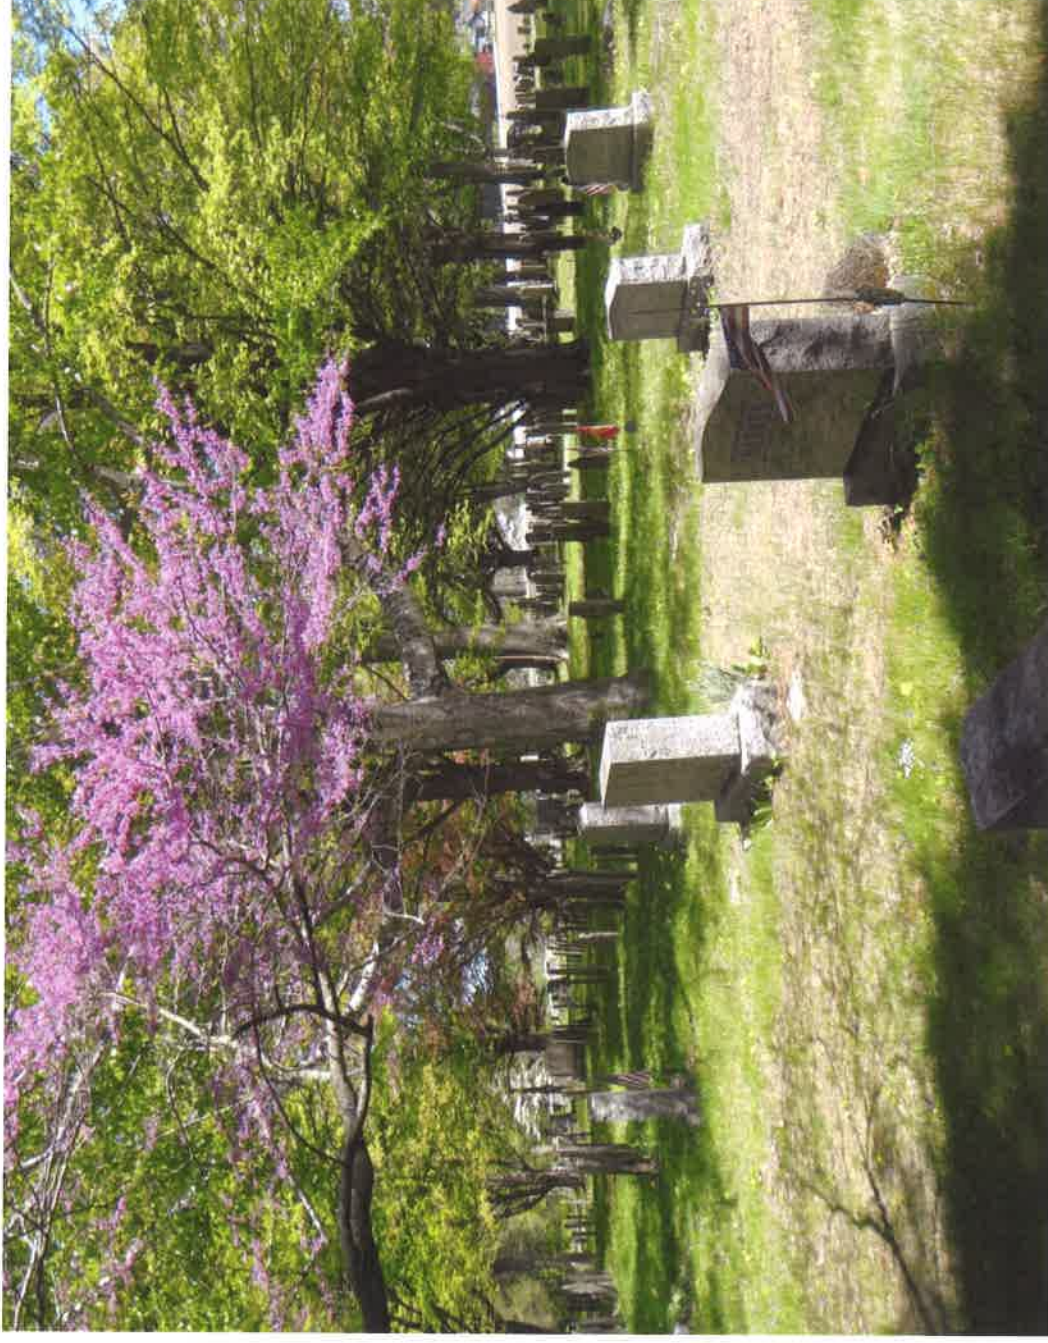
## Conservation Recommendations Riverside Cemetery, Sunderland, MA July 2018

EXISTING CONDITIONS  
Merrill Lynn Landscape Architecture, LLC  
2018

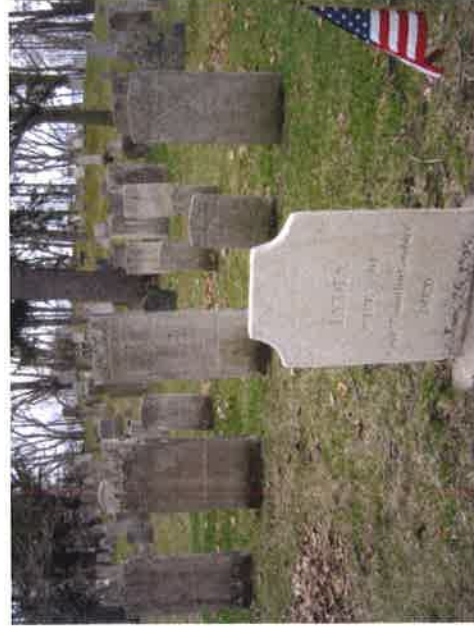
Cleaning of marble markers should be limited to those requiring structural adhesions. General cleaning of marbles would make the markers appear very white and the cemetery would appear historically inaccurate.

*The cleaning of one marble inappropriately stands out; and cleaning all the stones would be historically incorrect.*

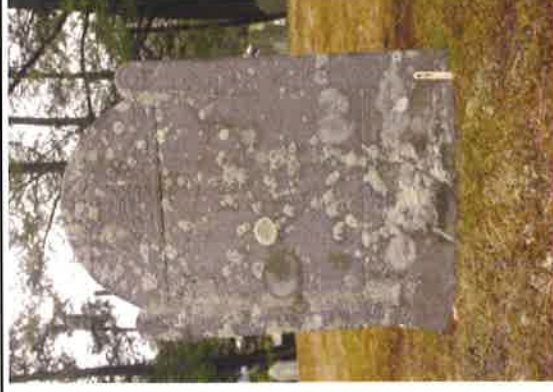
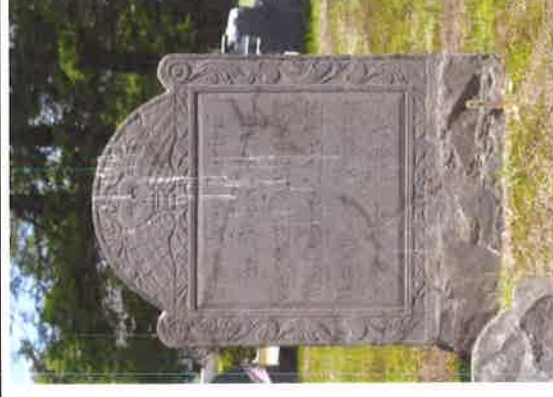
Other markers such as slate, schist and sandstone can be successfully cleaned without disturbing the overall aesthetics.

*Typical slate, before and after cleaning*

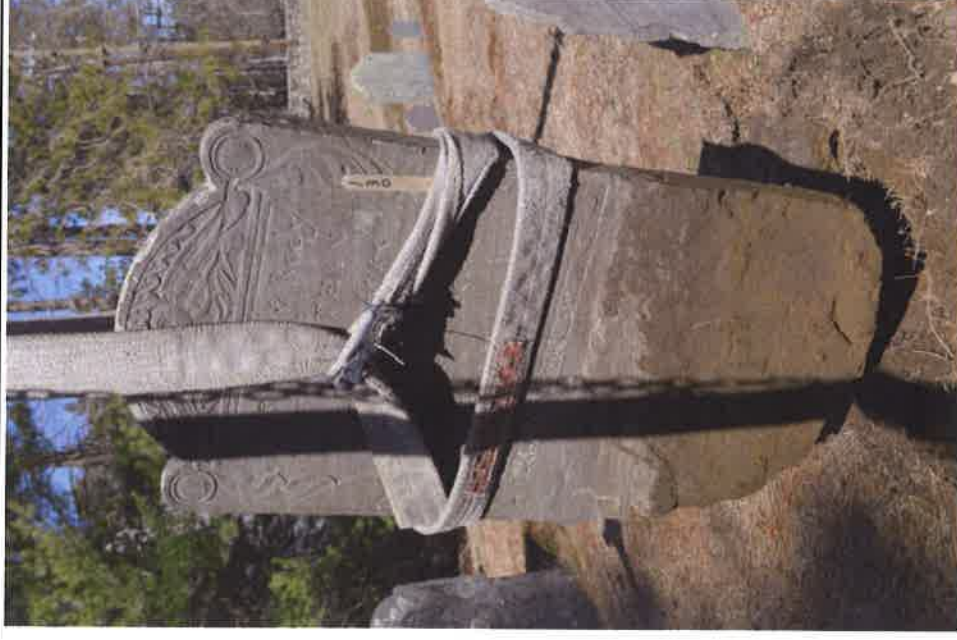
*18th century markers often have as much below the ground as above. Only upon excavating this marker for resetting does the massive below grade portion becomes apparent..*

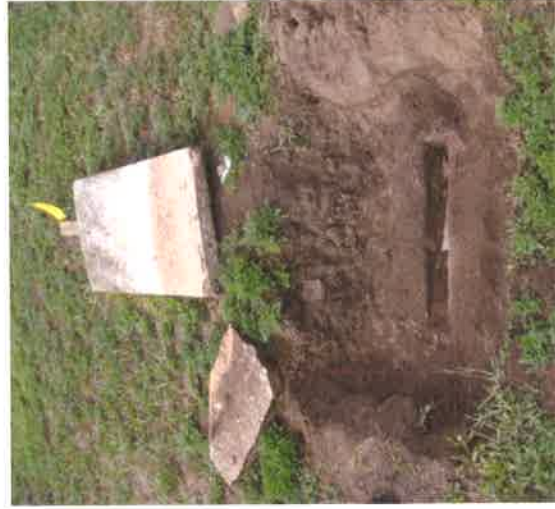
In many cases, markers have been set into below grade bases either originally or at a later date upon fracturing. When discovered, these bases can often be uncommonly deep, more than one foot.

*When excavating for resetting often original, or old bases are discovered*

Older bases should be carefully excavated, examined for soundness and reset level at a higher elevation and aligned with adjacent markers.

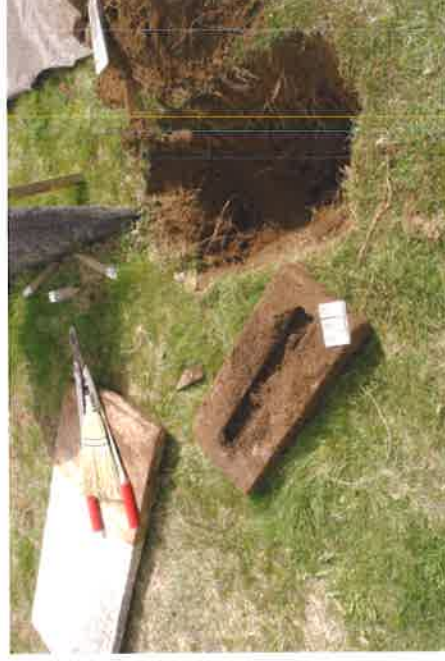
*Old base removed and inspected for soundness*

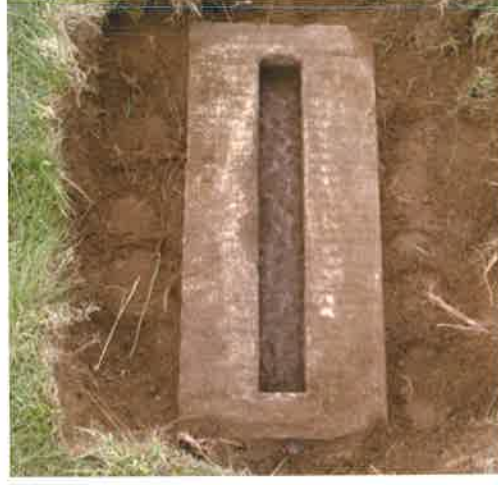
*Old base reset higher and aligned with adjacent markers*

Gravestones that required insertion into existing bases are to be set with a relatively weak cement/lime-based grout (3:2:9) with fine aggregates (00 or 000), made fluid with a high-range water reducer which ensures a complete fill.

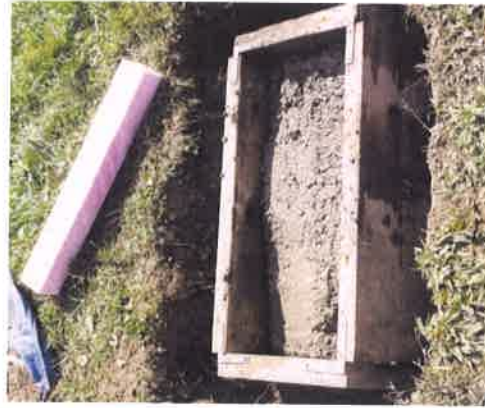
New below grade bases are made on site by casting in the ground with concrete. The casting is generally 9 to 12 inches deep, and 12 inches greater in thickness and 6 inches wider than the stone itself. The finished top surface of the base should be entirely below grade.

*Formwork for new base*

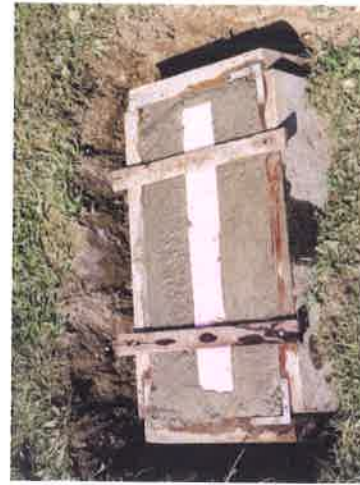
*Poured base with form insert for setting slot*

A form insert for a 1-inch deep setting slot, 1 1/2 inch wider and 1 inch thicker than the stone, is positioned in the concrete, in line with adjacent markers.

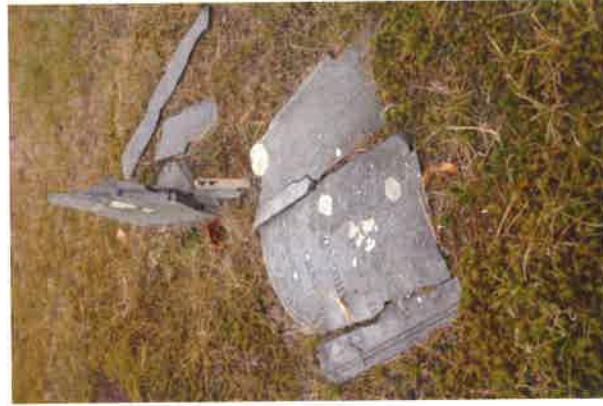
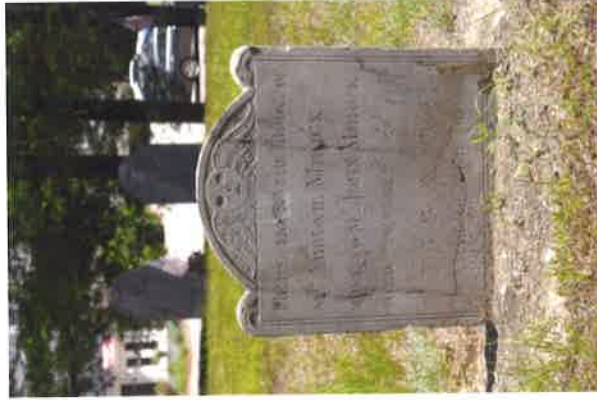
Most broken markers can be re-assembled with structural adhesives, without pinning. Bonding is dependent upon the soundness, cleanness and conformation of the fractured surfaces, factors often associated with the age of the break.

*Before and after restoration*

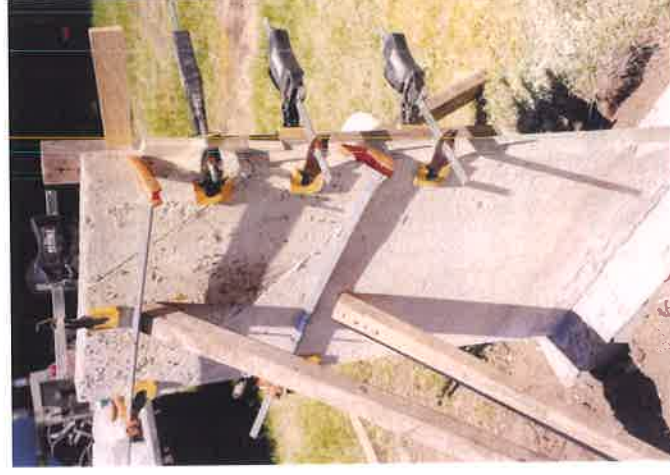
All bonding surfaces to be carefully cleaned and the fragments dry fitted. Aboweld 55-22 (Abatron, Inc.), a thixotropic, moisture-insensitive two-part epoxy, is thinly and evenly applied along both surfaces of the glue line, keeping slightly back from the edge of the break.

*Example of bracing and clamping*

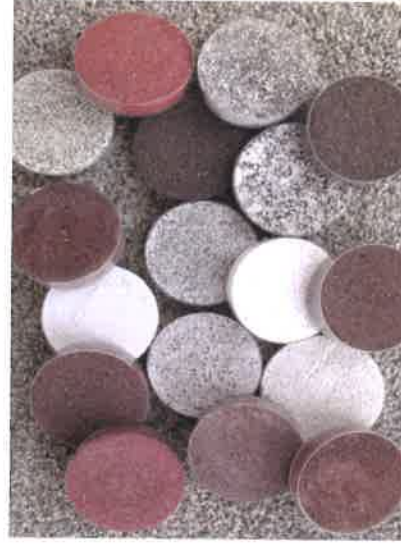
Examples of cement-lime repair mortars

Large losses in sandstone are filled with a custom-colored cementitious restoration mortar, such as Jahn™ M-70 (Cathedral Stone Products, Inc.). For marble, losses are filled with Jahn™ M-70 Custom Limestone Maximum White or with a marble-based repair composite designed to match the appearance of weathered surfaces. Most fine cracks can be filled with pigmented #400 PHLC Crack Filler (Voidspan), a pozzolanic hydraulic lime crack filler and grout.

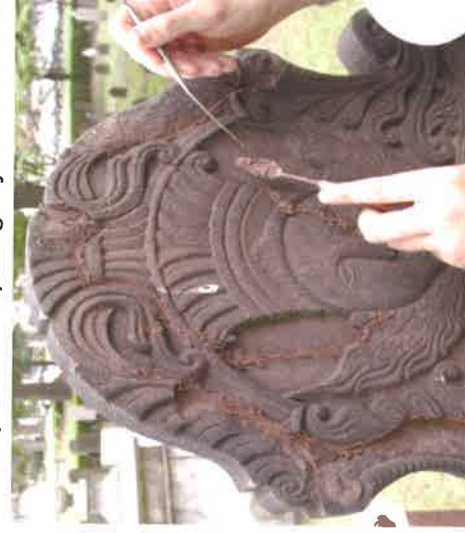
Filling cracks in a sandstone with a pigmented crack filler

Patching and crack filling should not be performed when the temperature of the air or of the stone surface is below 40 degrees Fahrenheit.

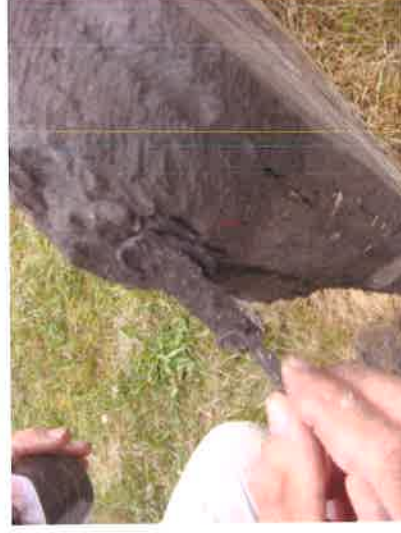
*Filling top cavities with a pigmented crack filler by Sto. Excess material to be immediately wiped off with damp sponging*

In “capping” a marker with delaminations, the voids are usually filled along the top side of the marker only. The sides are kept open to allow the escape of any water that may enter the interior. A pigmented flexible crack filler by STO can be used to fill openings up to 1/8” wide.

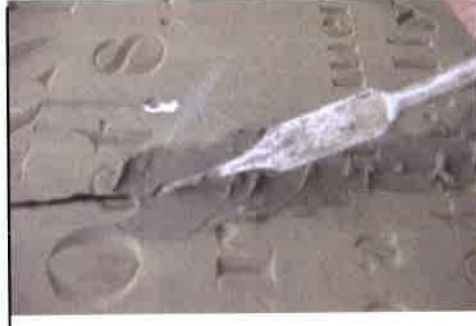
*A pigmented Sto Crack Filler being tooled into an open face crack*

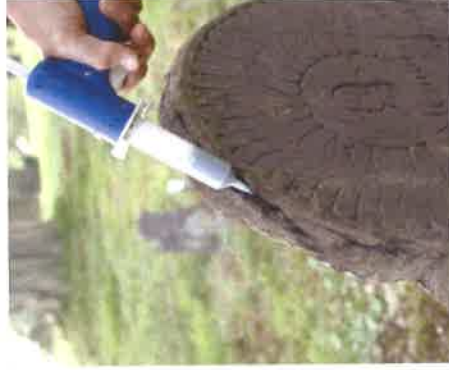
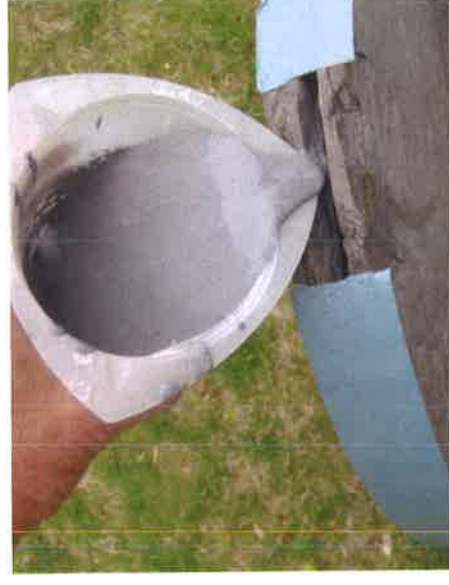
*Filling voids by syringe and by a flowable grout (VoidSpan)*

For larger voids, a pigmented PHLc Grout (a pozzolanic hydraulic lime manufactured by VoidSpan) can be used as a flowable grout.

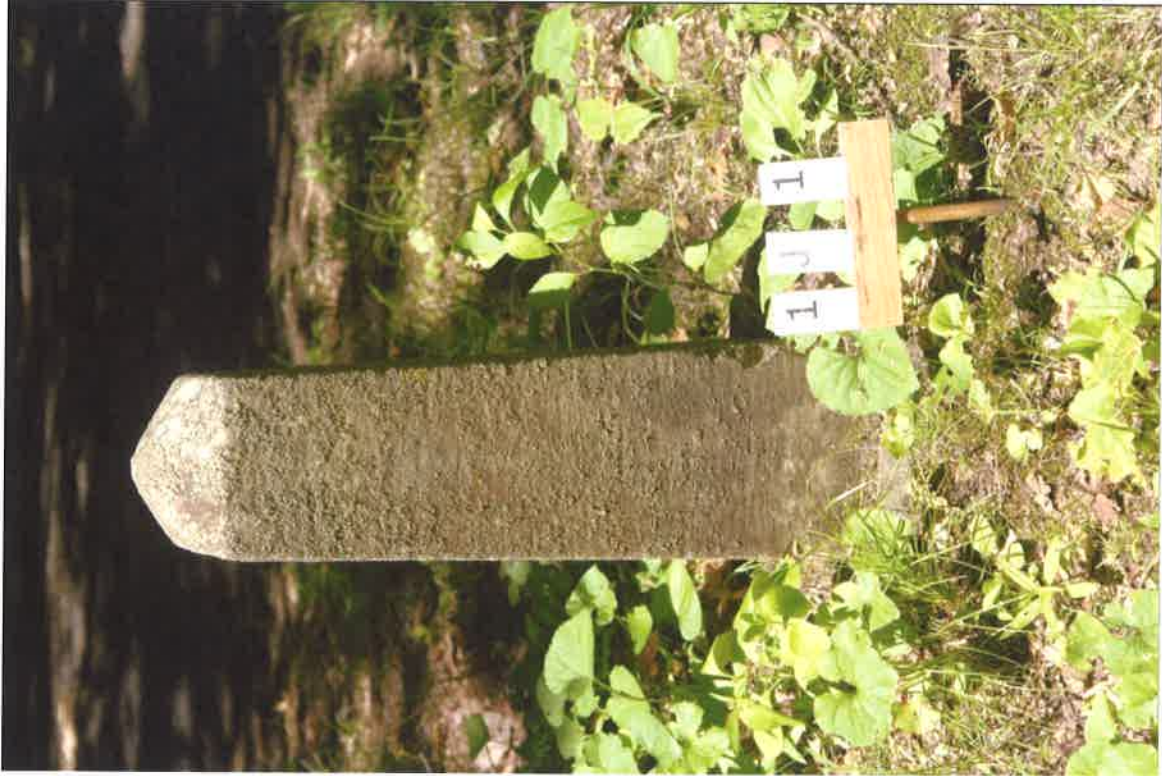
Riverside Cemetery Sunderland, MA  
NAME ON MARKER **Cooley**

| <b>EXISTING CONDITIONS</b><br>Unstable | <b>CONSERVATION STRATEGY</b><br>If required, level base.<br>Reset elements with cementitious lime mortar |

1. Inspect soundness of setting joint of marker to base, if unstable, remove from base.
2. Excavate area around existing base.
3. Align base with adjacent markers and re-set level and plumb.
4. Backfill with tamped gravel and re-grade with existing topsoil
5. If setting joint was unsound, remove failed setting mortar and replace setting pins with stainless pins if necessary.
6. Prime setting surfaces with Acryl 60 diluted 1:3 with water.
7. Re-set marker plumb onto base with cementitious hi-cal lime mortar
8. Remove excess grout and brace marker until cured.

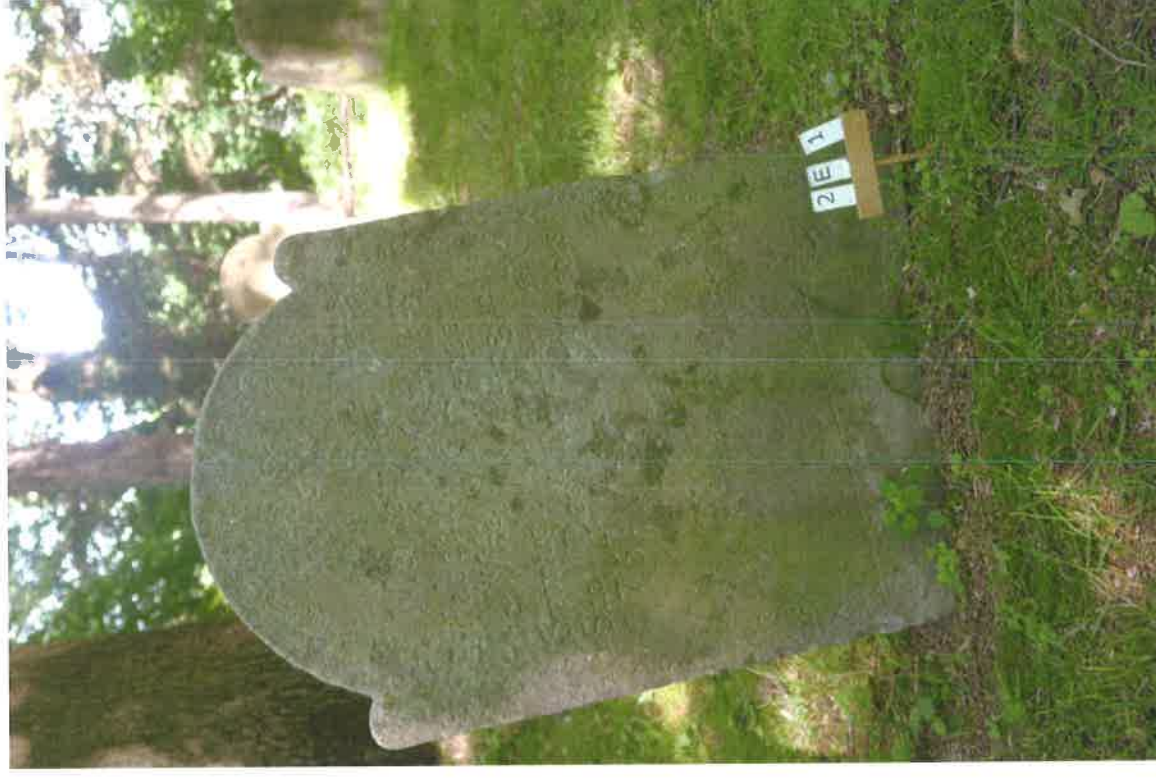
Riverside Cemetery    Sunderland, MA  
NAME ON MARKER    **Zaccheus Crocker**

Loose in ground

1. Carefully excavate marker. Inspect marker/ base for soundness.
2. If original base is sound or adequate below grade length is found for resetting (over 18"), ideally 24", reset marker plumb.
3. If unsound material or less than 18" is found, new below grade cast concrete base will be required. Sized minimum of 12 inches deep, 12 inches greater in thickness and 6 inches wider than the stone. The finished top to be entirely below grade. Align the setting slot (1" deep, 1/2" wider and thicker than the marker) with adjacent markers.
4. If required, re-square the lower edge of marker with min. loss.
5. After min 3 day cure, remove the setting form and reset marker plumb and level into slot using a cement/lime grout (3/2/9) Brace for minimum of 5 days.
6. Backfill disturbed areas with tamped sand and gravel, and re-grade with existing topsoil.

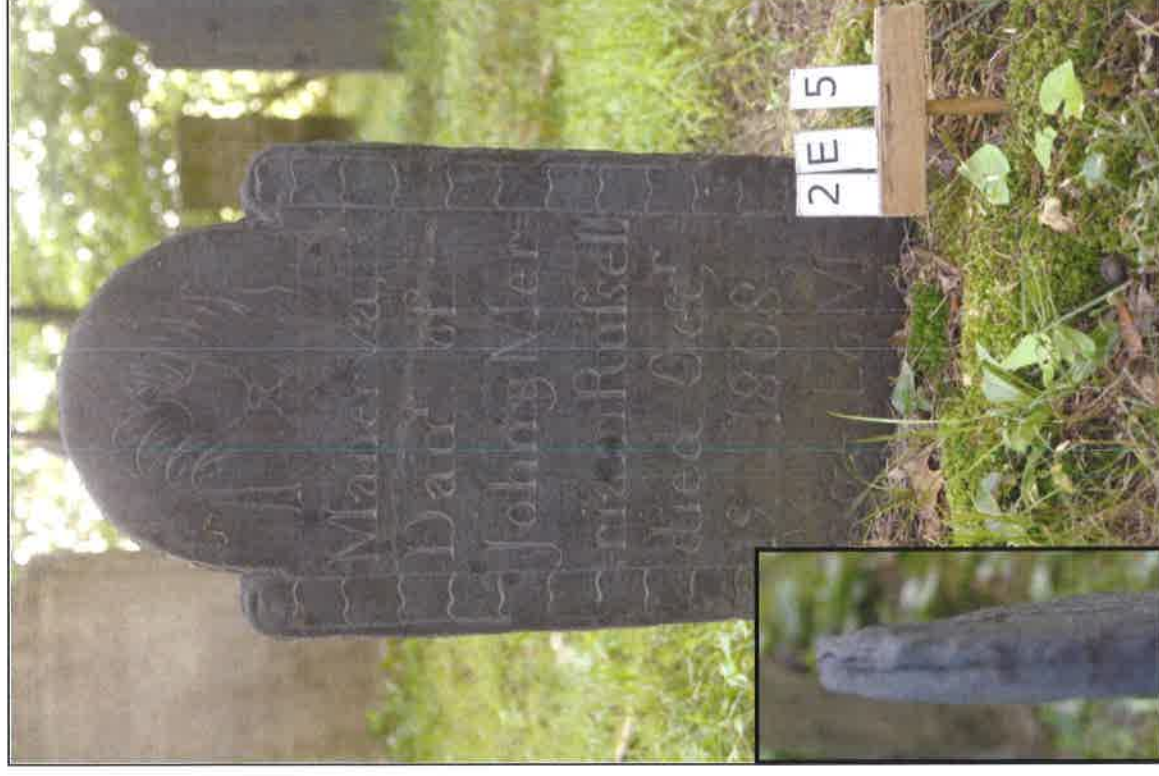
Marker# 2E.5

Set too low  
Possible below grade fracture  
Reset into new below grade base

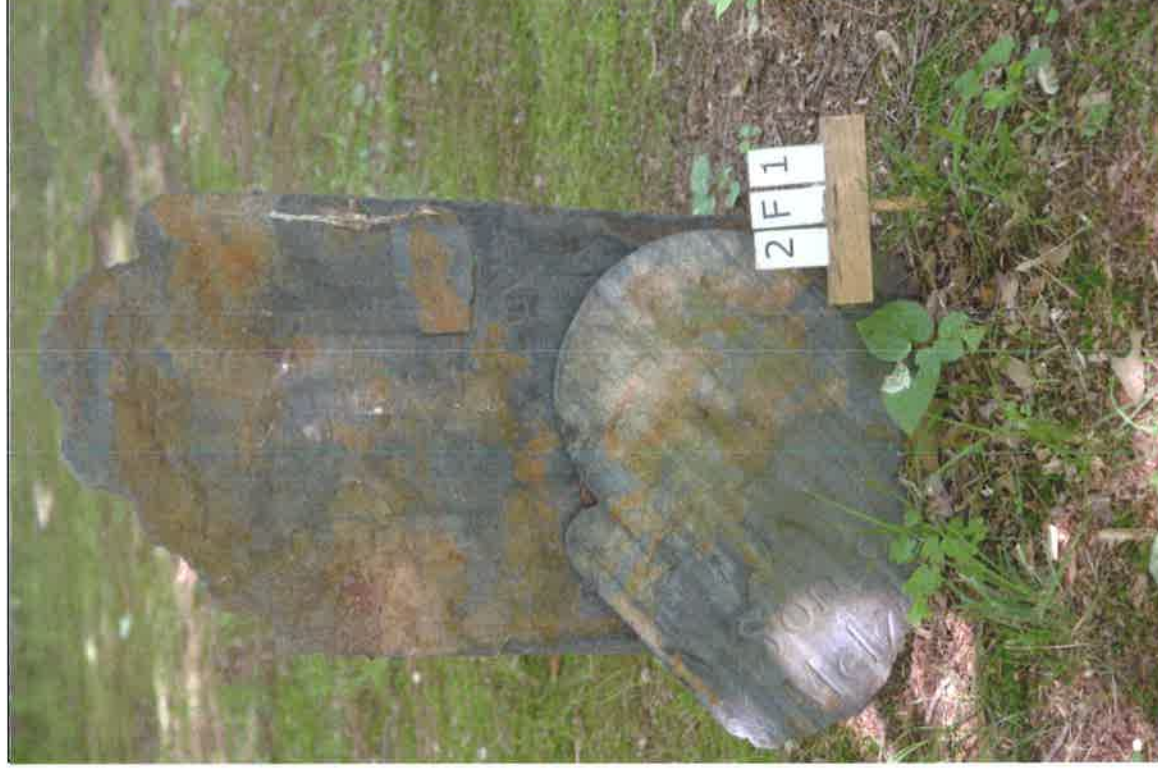
Marker# 2F.1

**EXISTING CONDITIONS** **CONSERVATION STRATEGY**  
Delaminating Fills voids caused by delaminating slate

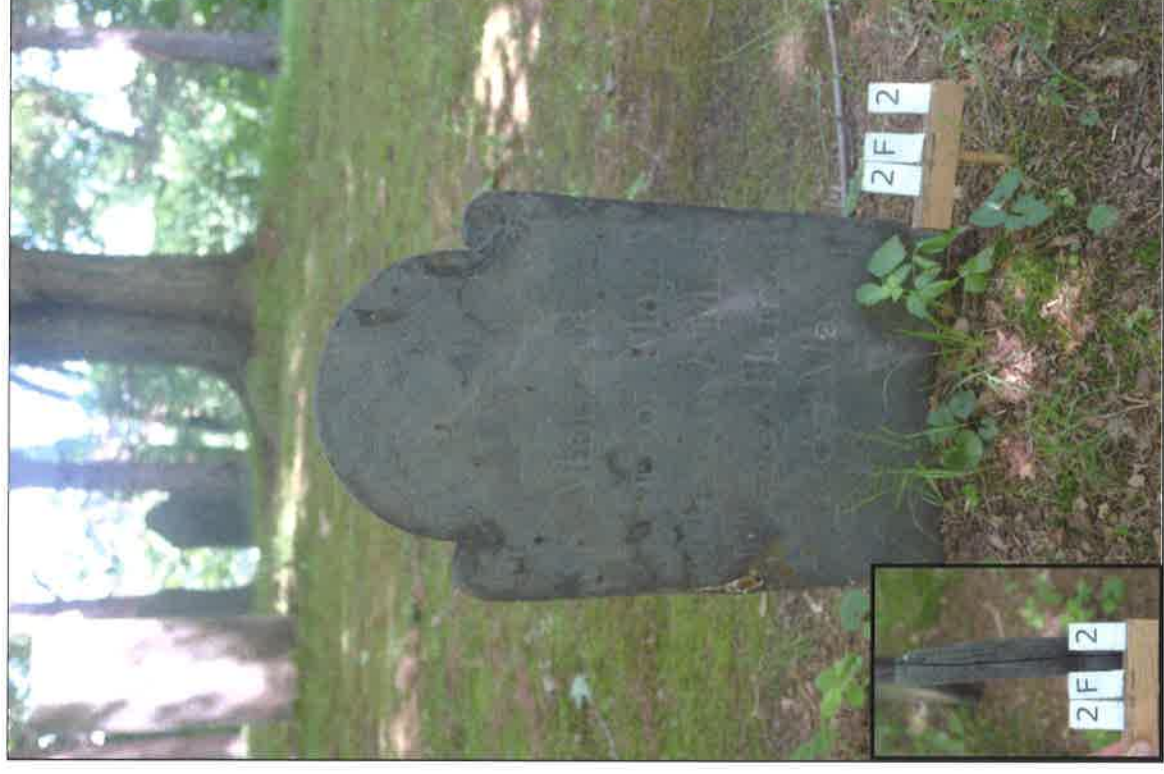
Marker# 2F.2

Possible below grade fracture

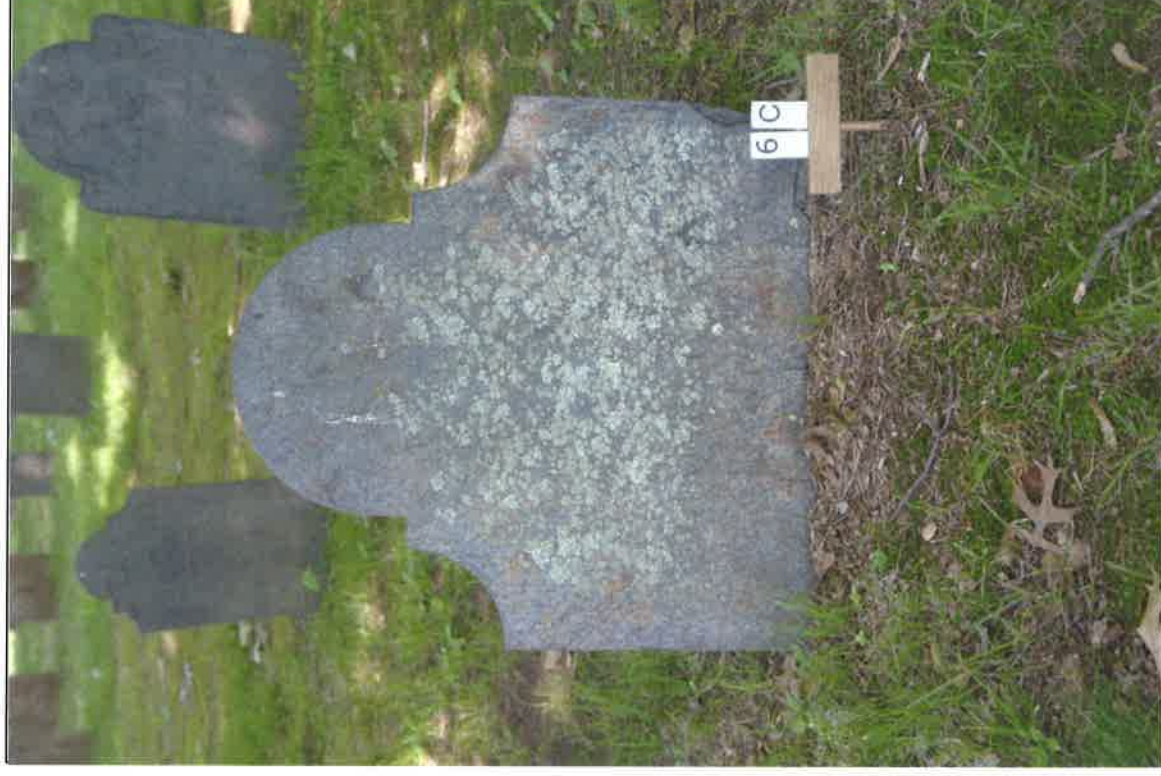
Marker# 6C.1

**EXISTING CONDITIONS**  
Delaminating

**CONSERVATION STRATEGY**  
Fills voids caused by delaminating slate

1. Flush interior voids with water and remove any lichens and/or debris with hand tools.
2. After full drying, all voids caused by splitting or delaminations at top edge of marker filled with a pigmented Sto Crack Filler using injection syringes and/or trowels. Voids along the lower sides of monument typically left open to allow escape of any water which may enter.
3. Excess crack filler immediately removed with damp sponging.
4. Large voids filled with a pigmented PHLc flowable grout

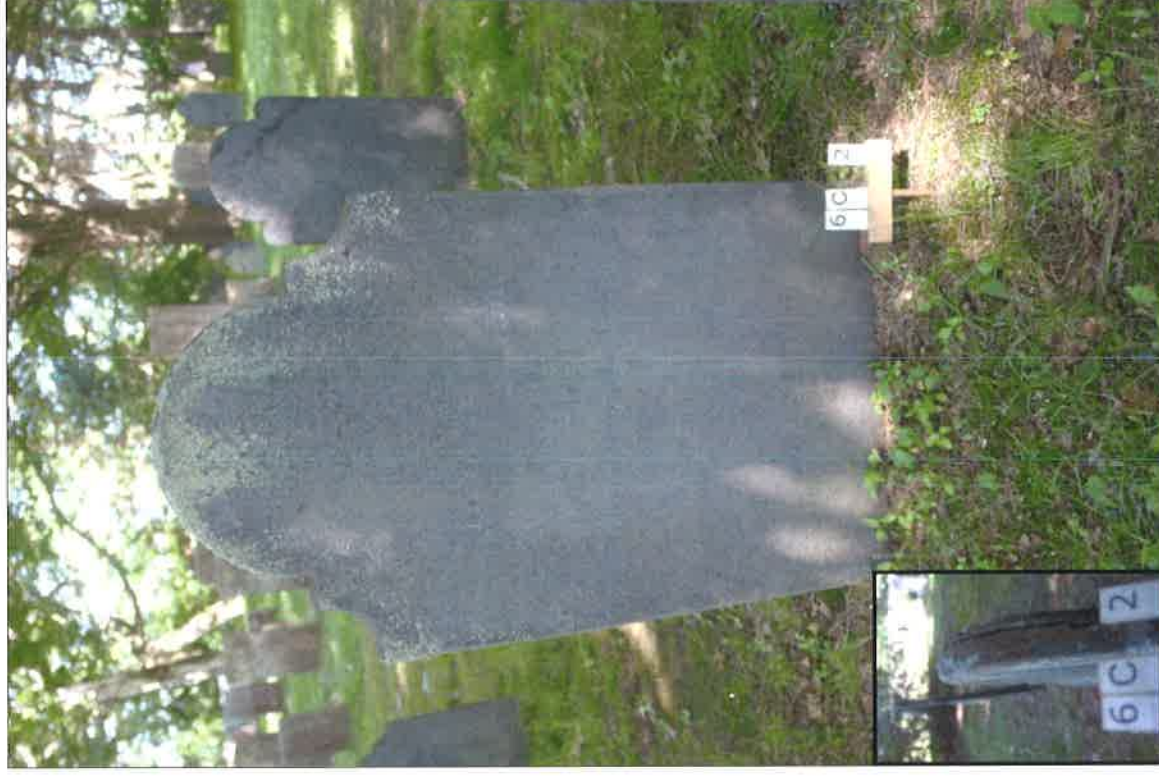
**EXISTING CONDITIONS**  
Delaminating

**CONSERVATION STRATEGY**  
Fills voids caused by delaminating  
slate

1. Flush interior voids with water and remove any lichens and/or debris with hand tools.
2. After full drying, all voids caused by splitting or delaminations at top edge of marker filled with a pigmented Sto Crack Filler using injection syringes and/or trowels. Voids along the lower sides of monument typically left open to allow escape of any water which may enter.
3. Excess crack filler immediately removed with damp sponging.
4. Large voids filled with a pigmented PHLc flowable grout

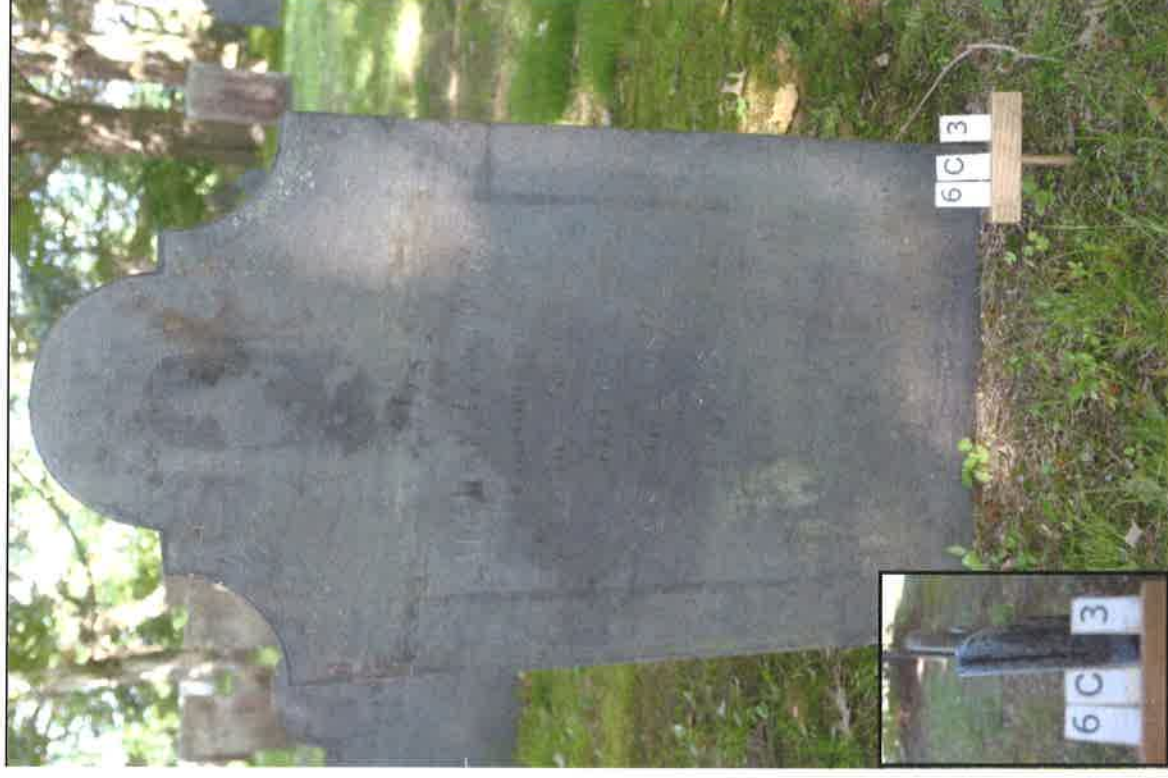
Marker# 6C.3

**EXISTING CONDITIONS**  
Delaminating

**CONSERVATION STRATEGY**  
Fills voids caused by delaminating slate

1. Flush interior voids with water and remove any lichens and/or debris with hand tools.
2. After full drying, all voids caused by splitting or delaminations at top edge of marker filled with a pigmented Sto Crack Filler using injection syringes and/or trowels. Voids along the lower sides of monument typically left open to allow escape of any water which may enter.
3. Excess crack filler immediately removed with damp sponging.
4. Large voids filled with a pigmented PHLC flowable grout

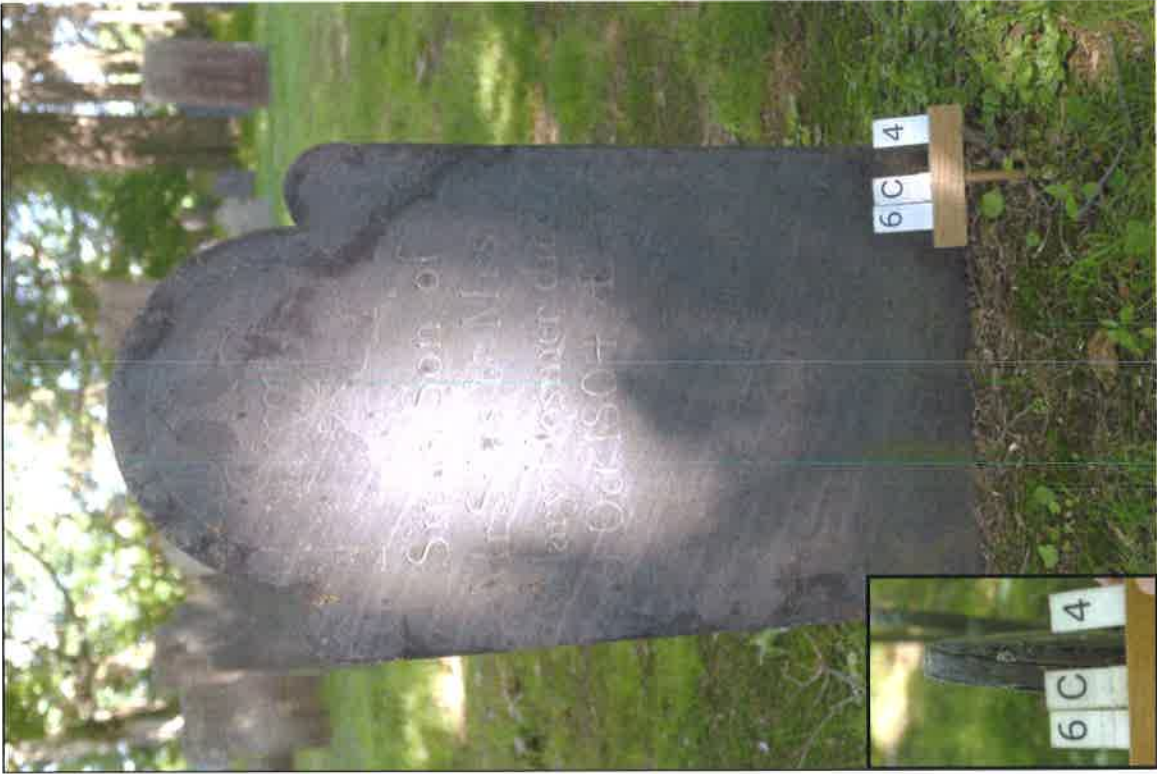
Marker# 6C.4

| <b>EXISTING CONDITIONS</b><br>Delaminating | <b>CONSERVATION STRATEGY</b><br>Fills voids caused by delaminating slate |

1. Flush interior voids with water and remove any lichens and/or debris with hand tools.
2. After full drying, all voids caused by splitting or delaminations at top edge of marker filled with a pigmented Sto Crack Filler using injection syringes and/or trowels. Voids along the lower sides of monument typically left open to allow escape of any water which may enter.
3. Excess crack filler immediately removed with damp sponging.
4. Large voids filled with a pigmented PHLc flowable grout

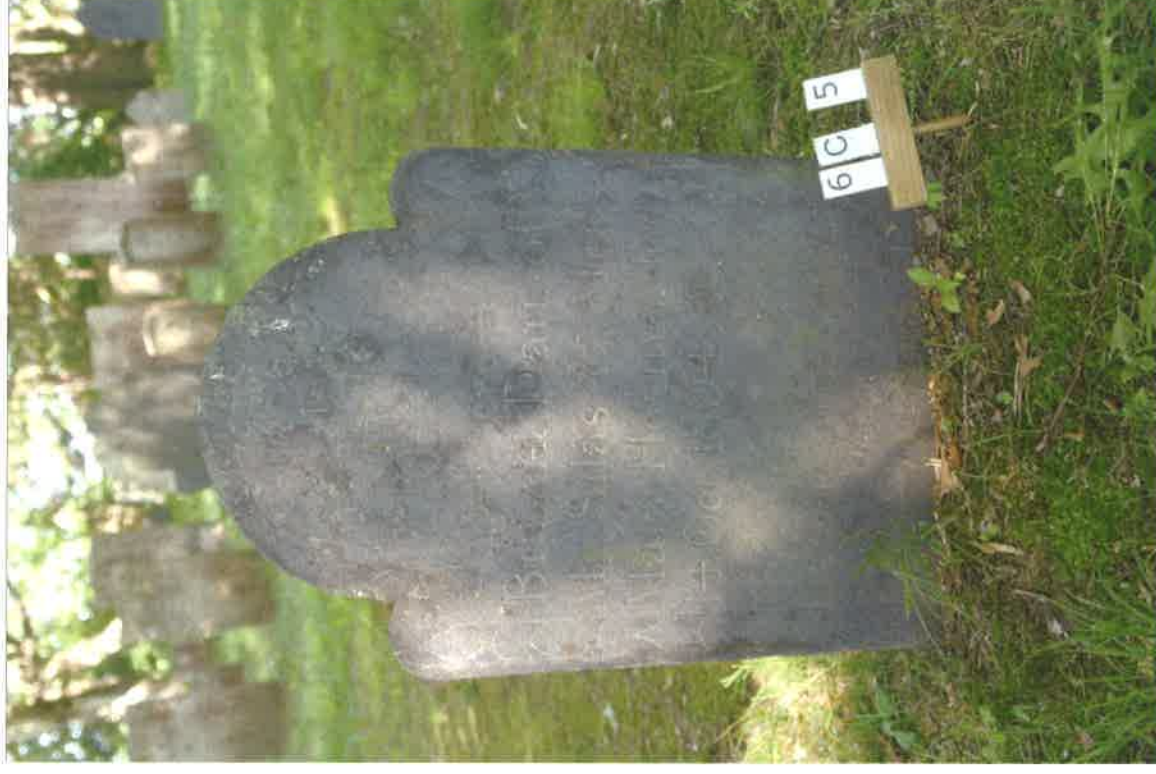
Marker# 6C.5

#### EXISTING CONDITIONS

Fractured

1. Clean all mating edges of fragments with water and remove any failed adhesives with hand tools
2. Attach fragments with structural adhesive (Abatron 55-22), clamp and brace until cured.
3. Remove excess epoxy with hand chisels within 24 hours
4. Fill cracks and voids with approved cementitious products.
5. Mist filled areas with water and keep covered for 3 days min.
6. Treat filled surface areas with light acid wash and rinse thoroughly with water

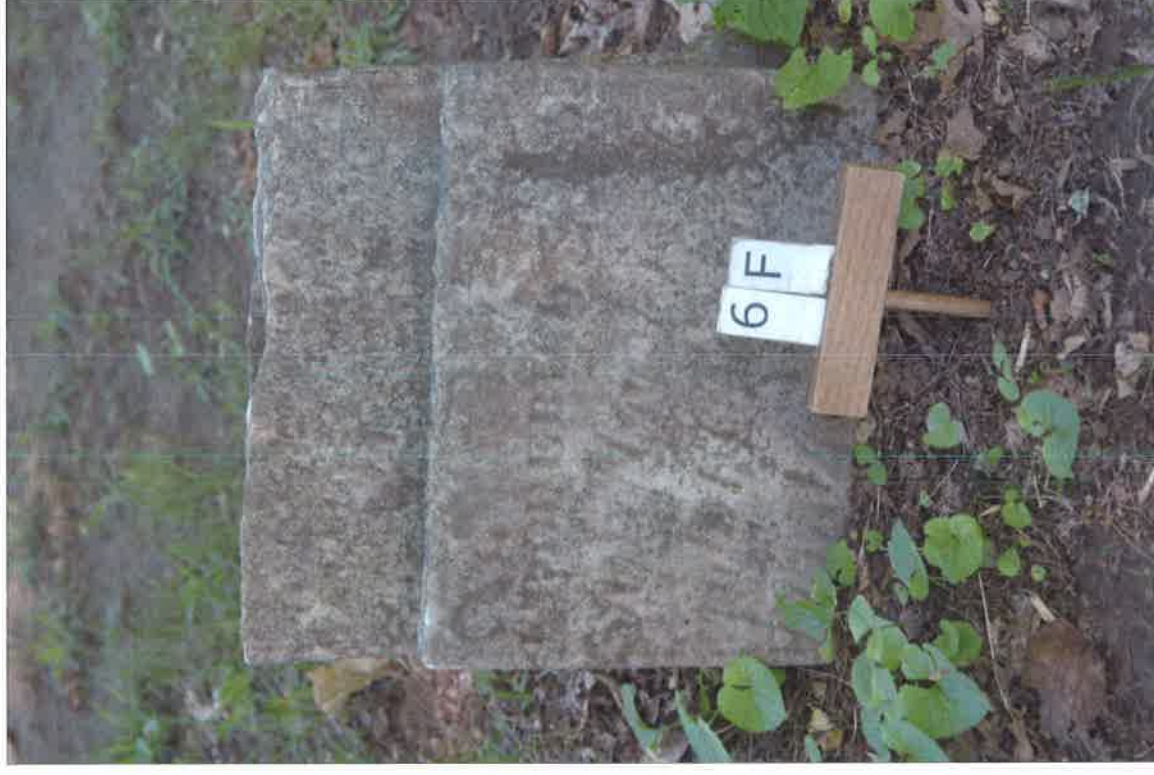
Marker# 6F.1

Treat bio-growth and remove soiling  
Fills voids caused by delaminating stone

1. Flush delaminated voids with water and remove any lichens and/or debris with hand tools.
2. Treat all surfaces with D/2 biological solution and scrub with nylon brushes. Use wooden or plastic scrapers to remove stubborn lichens. Rinse fully with water
3. Repeat applications of D/2 and scrubbing as necessary, rinsing with water.
4. After full drying, all voids caused by splitting or delaminations at top edge of marker filled with a pigmented Sto Crack Filler using injection syringes and/or trowels. Voids along the lower sides of monument typically left open to allow escape of any water which may enter.
5. Excess crack filler immediately removed with damp sponging.
6. Large voids filled with a pigmented PHLc flowable grout

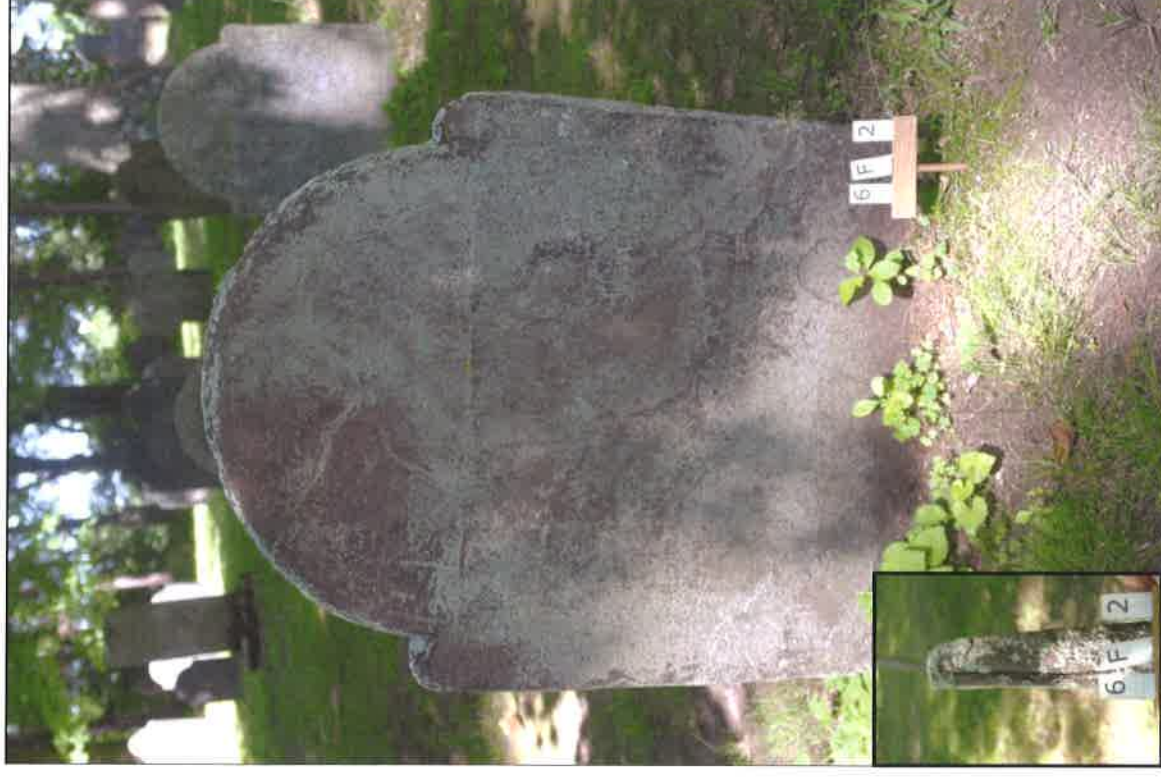
Marker# 6F.2

**EXISTING CONDITIONS**  
Fractured

1. Clean all mating edges of fragments with water and remove any failed adhesives with hand tools
2. Attach fragments with structural adhesive (Abatron 55-22), clamp and brace until cured.
3. Remove excess epoxy with hand chisels within 24 hours
4. Fill cracks and voids with approved cementitious products.
5. Mist filled areas with water and keep covered for 3 days min.
6. Treat filled surface areas with light acid wash and rinse thoroughly with water
