# Preservation Master Plan

*Riverside Cemetery  
Sunderland, Massachusetts*

**Martha Lyon Landscape Architecture, LLC**  
*313 Elm Street  
Northampton, MA 01060  
413-586-4178  
[www.marthalyon.com](http://www.marthalyon.com)*

**Monument Conservation Collaborative, LLC**  
*P. O. Box 541  
Norfolk, CT 06058  
860-309-9491  
[www.mcc-monument-conservation.com](http://www.mcc-monument-conservation.com)*

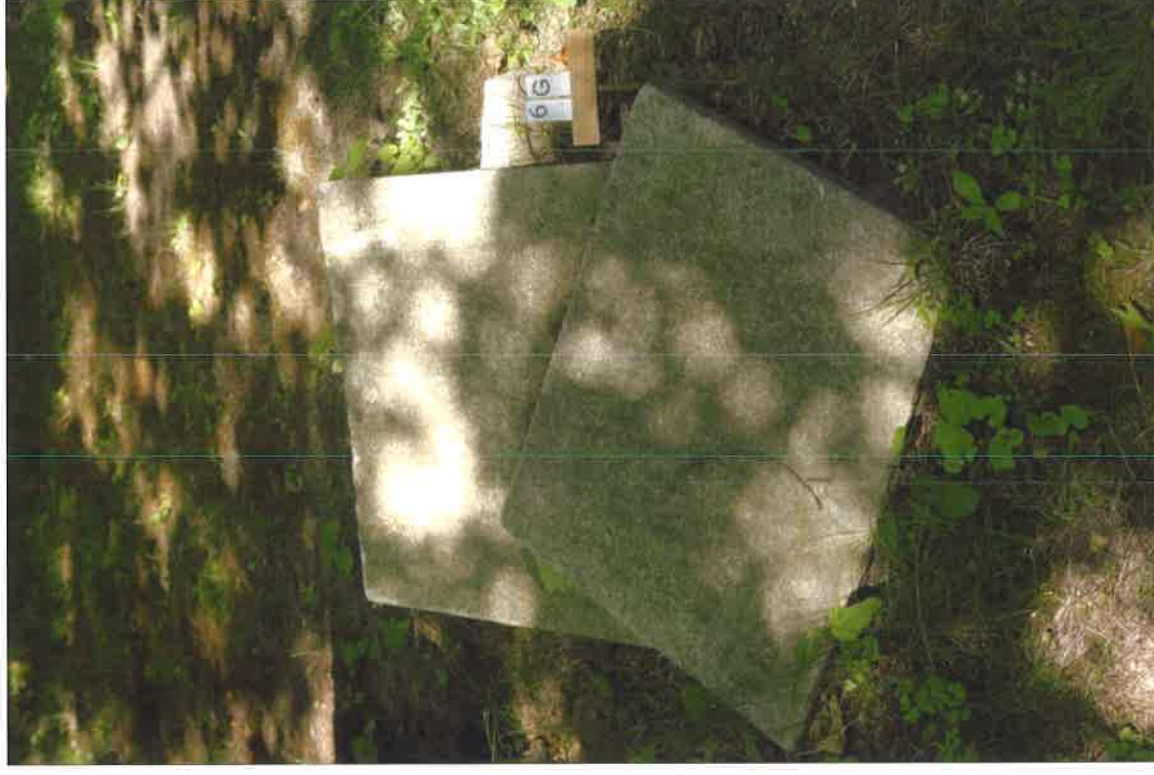
Marker# 6G.1

**EXISTING CONDITIONS CONSERVATION STRATEGY**  
Set too low Reset into new below grade base  
Possible below grade fracture

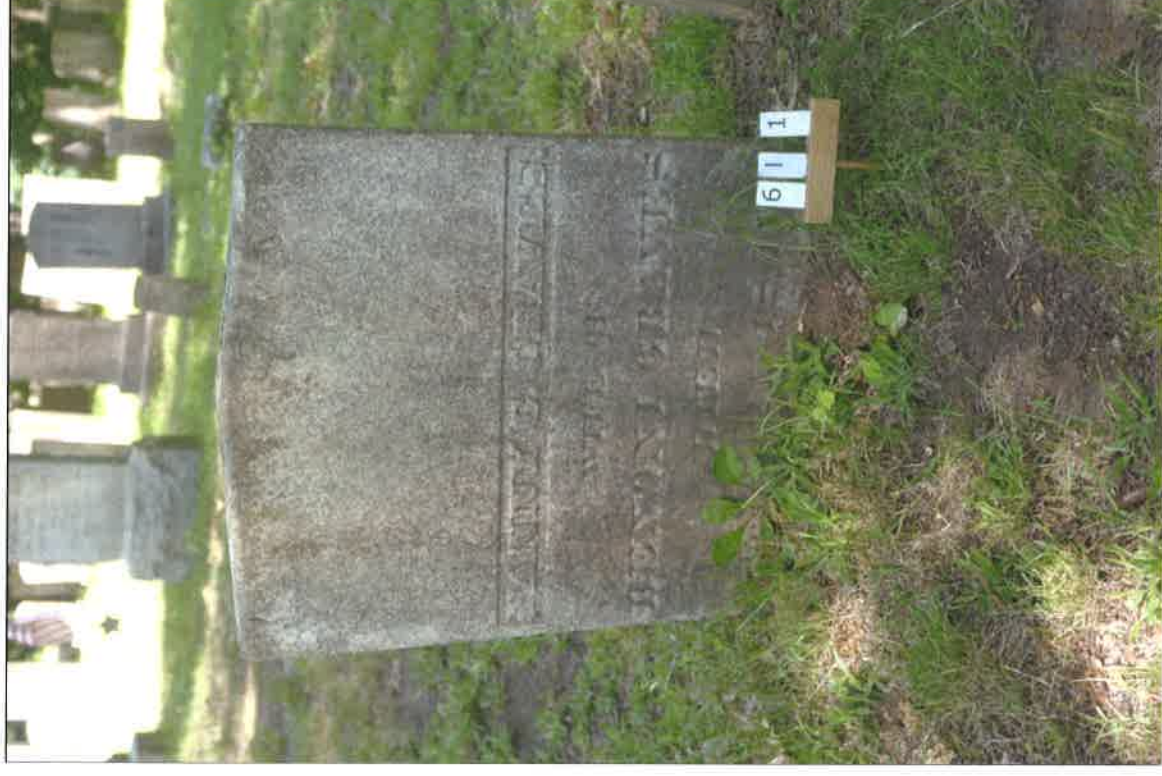
Marker# 61.1

Tilted, loose in ground  
Poss below grade fracture

Probe to evaluate resetting conditions.  
Possible resetting into new below grade base

1. Carefully excavate marker. Inspect marker/ base for soundness.
2. If original base is sound or adequate below grade length is found for resetting (over 18"), ideally 24", reset marker plumb.
3. If unsound material or less than 18" is found, new below grade cast concrete base will be required. Sized minimum of 12 inches deep, 12 inches greater in thickness and 6 inches wider than the stone. The finished top to be entirely below grade. Align the setting slot (1" deep, 1/2" wider and thicker than the marker) with adjacent markers.
4. If required, re-square the lower edge of marker with min. loss.
5. After min 3 day cure, remove the setting form and reset marker plumb and level into slot using a cement/lime grout (3/2/9) Brace for minimum of 5 days.
6. Backfill disturbed areas with tamped sand and gravel, and re-grade with existing topsoil.

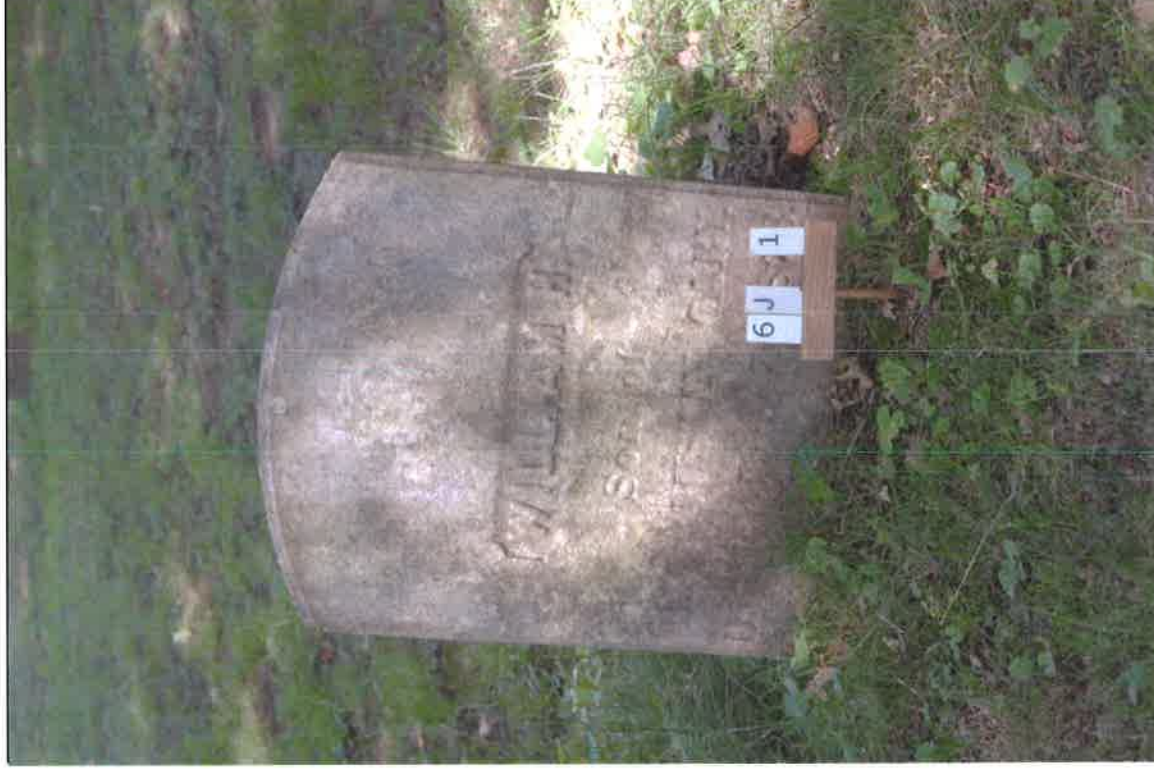
Marker# 6J.1

**EXISTING CONDITIONS** **CONSERVATION STRATEGY**  
Fractured Reset plumb and attach fragments  
with structural adhesive

1. Reset lower, inground fargmnet plumb.
2. Clean all mating edges of fragments with water and remove any failed adhesives with hand tools
3. Attach fragments with structural adhesive (Abatron 55-22), clamp and brace until cured.
4. Remove excess epoxy with hand chisels within 24 hours
5. Fill cracks and voids with approved cementitious products.
6. Mist filled areas with water and keep covered for 3 days min.
7. Treat filled surface areas with light acid wash and rinse thoroughly with water

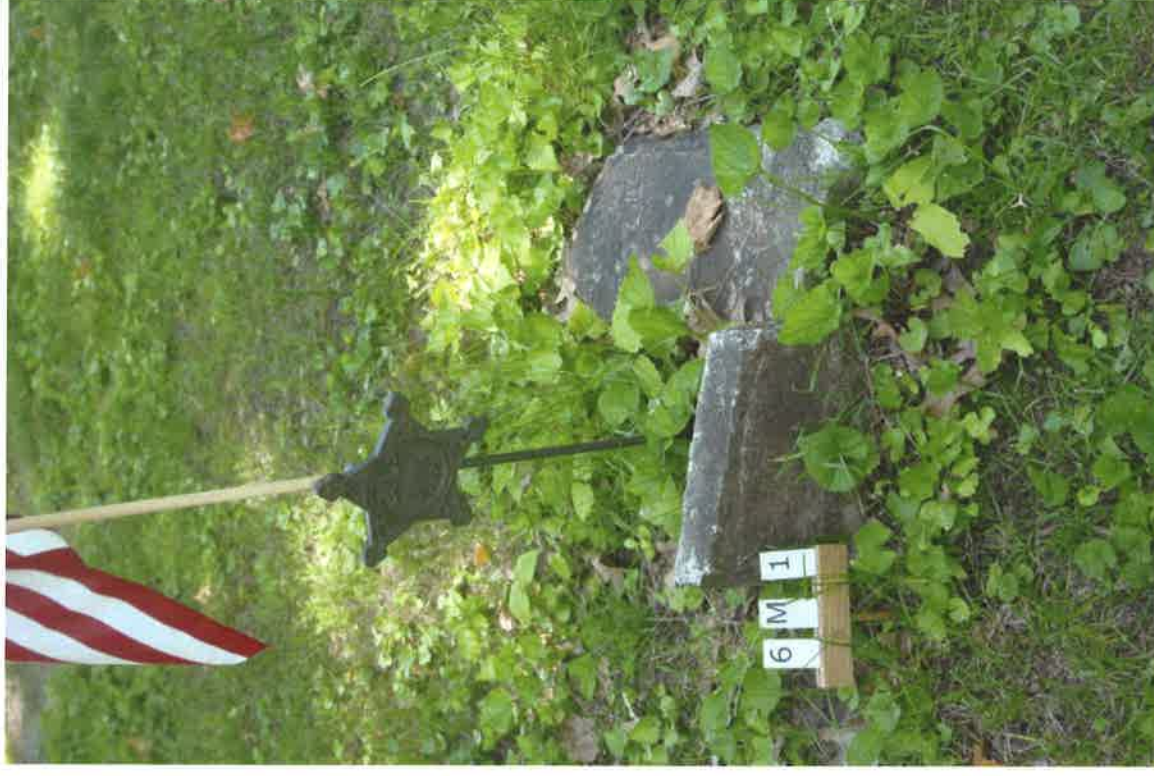
Marker# 6M.1

Unstable  
Failed repair

Probe to evaluate resetting conditions.  
Possible resetting into new below grade base

1. Carefully excavate marker. Inspect marker/ base for soundness.
2. If original base is sound or adequate below grade length is found for resetting (over 18"), ideally 24", reset marker plumb.
3. If unsound material or less than 18" is found, new below grade cast concrete base will be required. Sized minimum of 12 inches deep, 12 inches greater in thickness and 6 inches wider than the stone. The finished top to be entirely below grade. Align the setting slot (1" deep, 1/2" wider and thicker than the marker) with adjacent markers.
4. If required, re-square the lower edge of marker with min. loss.
5. After min 3 day cure, remove the setting form and reset marker plumb and level into slot using a cement/lime grout (3/2/9) Brace for minimum of 5 days.
6. Backfill disturbed areas with tamped sand and gravel, and re-grade with existing topsoil.

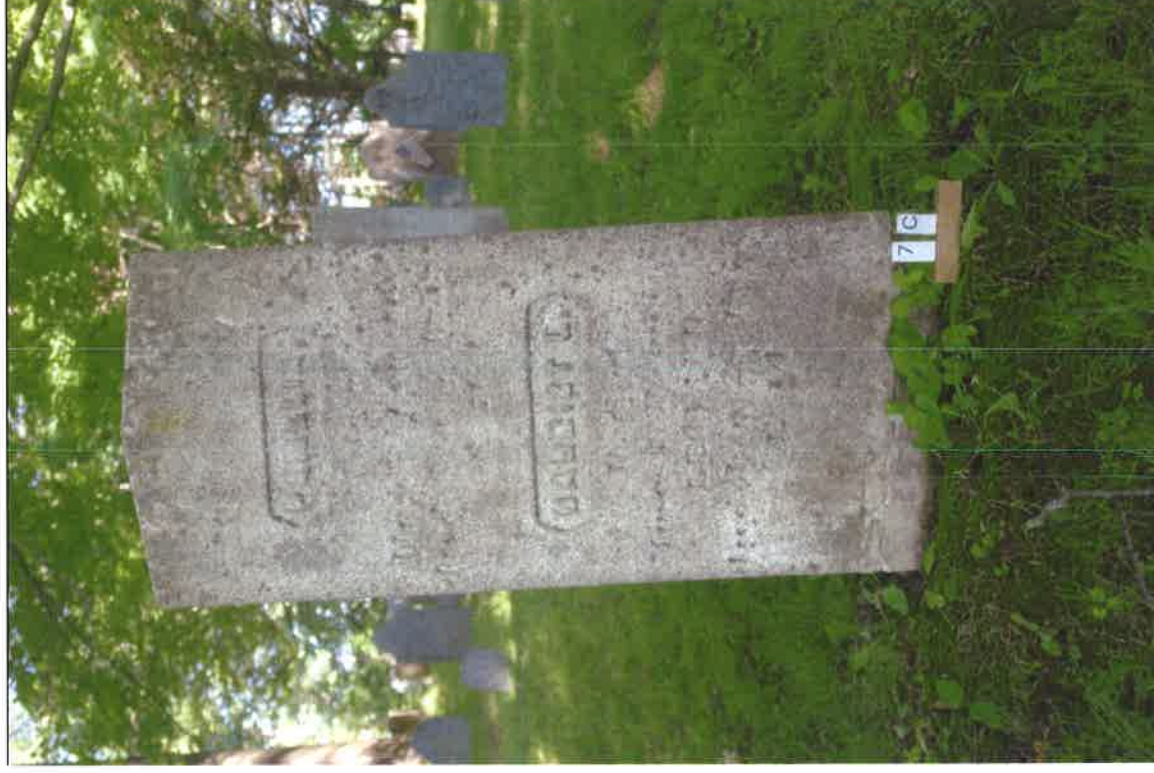
| <b>EXISTING CONDITIONS</b><br>Out of ground | <b>CONSERVATION STRATEGY</b><br>Reset into new below grade base |

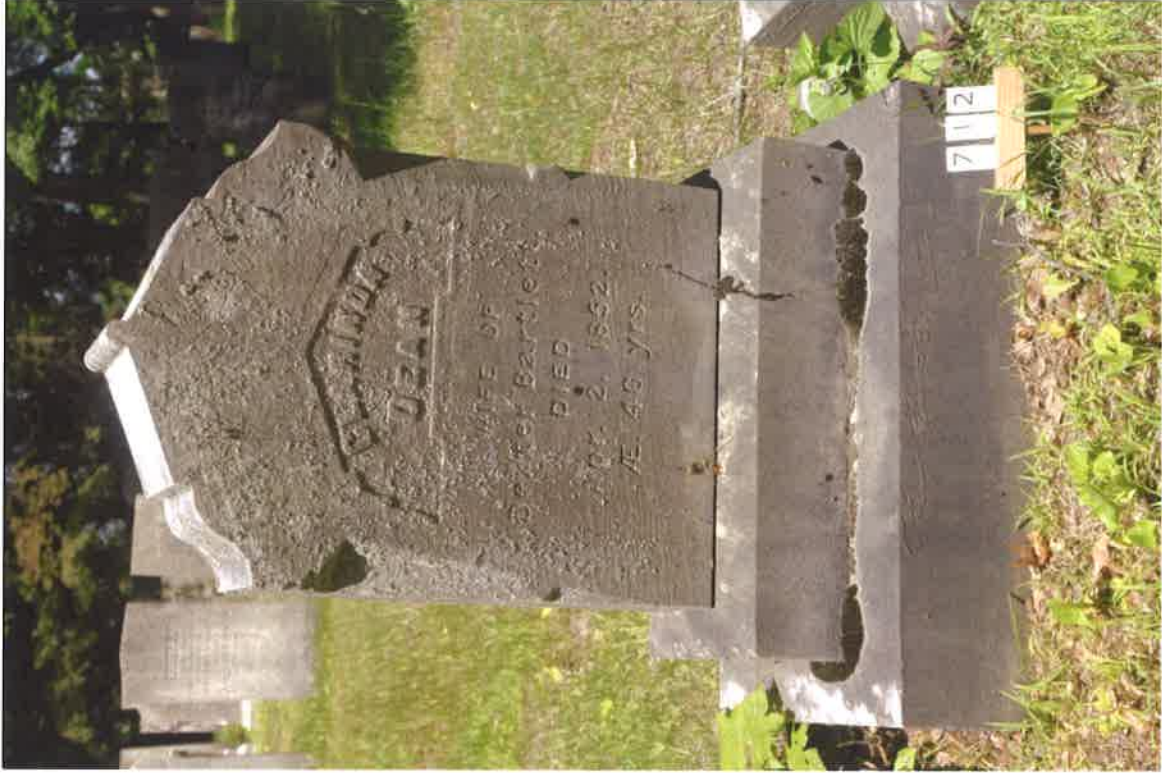
Death Date: 12/23/1891 Marker Type: Headstone on base  
Cond. of Inscription: Decipherable Material: Marble

**EXISTING CONDITIONS** **CONSERVATION STRATEGY**  
Unstable If required, level base.  
Reset elements with cementitious lime mortar

1. Inspect soundness of setting joint of marker to base, if unstable, remove from base.
2. Excavate area around existing base.
3. Align base with adjacent markers and re-set level and plumb.
4. Backfill with tamped gravel and re-grade with existing topsoil
5. If setting joint was unsound, remove failed setting mortar and replace setting pins with stainless pins if necessary.
6. Prime setting surfaces with Acryl 60 diluted 1:3 with water.
7. Re-set marker plumb onto base with cementitious hi-cal lime mortar
8. Remove excess grout and brace marker until cured.

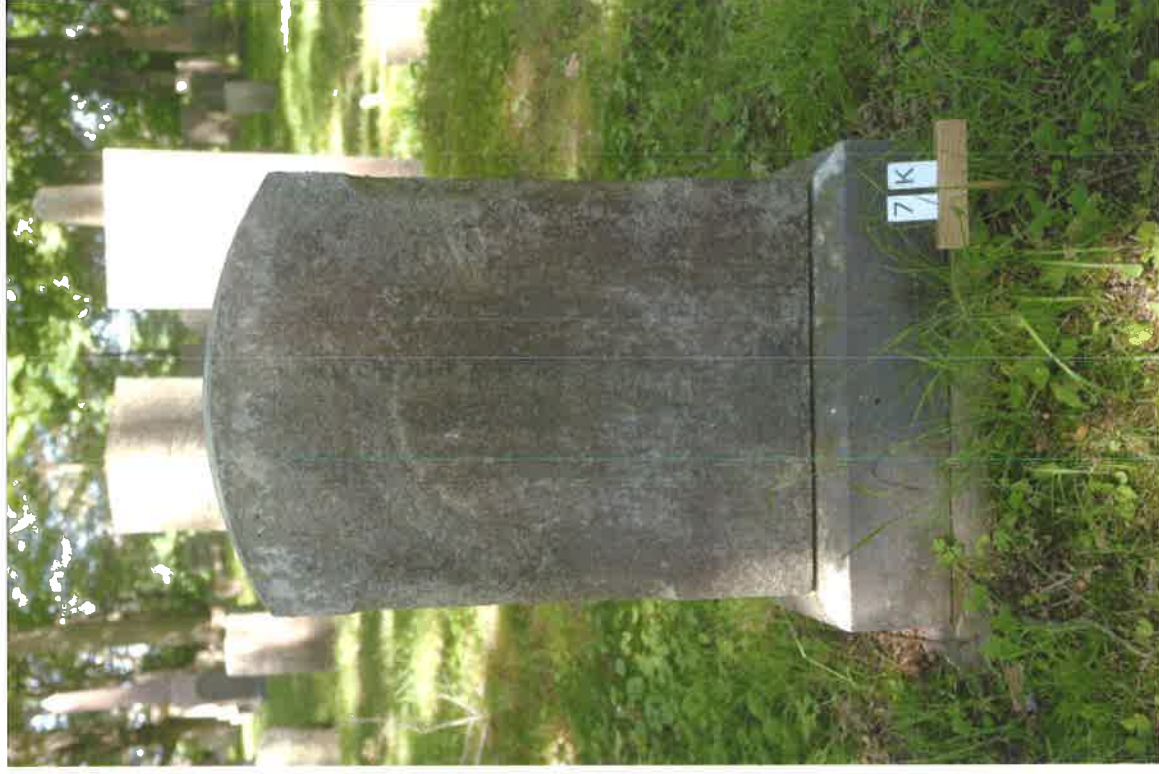
Marker# 7K.1

| <b>EXISTING CONDITIONS</b><br>Fractured | <b>CONSERVATION STRATEGY</b><br>Poss new base<br>Attach fragments with structural adhesive |

1. Excavate marker and fragments. Remove any previous failed repairs.
2. If adequate below grade length is found for resetting, reset lower marker fragment plumb in ground.

3. If unsound material is found a new below grade cast concrete base will be required. Sized minimum of 12 inches deep, 12 inches greater in thickness and 6 inches wider than the stone. The finished top to be entirely below grade. Align the setting slot with adjacent markers.

8. Fill cracks and losses with RepliCal and Jahn products.
9. Mist filled areas with water and cover for 3 days minimum

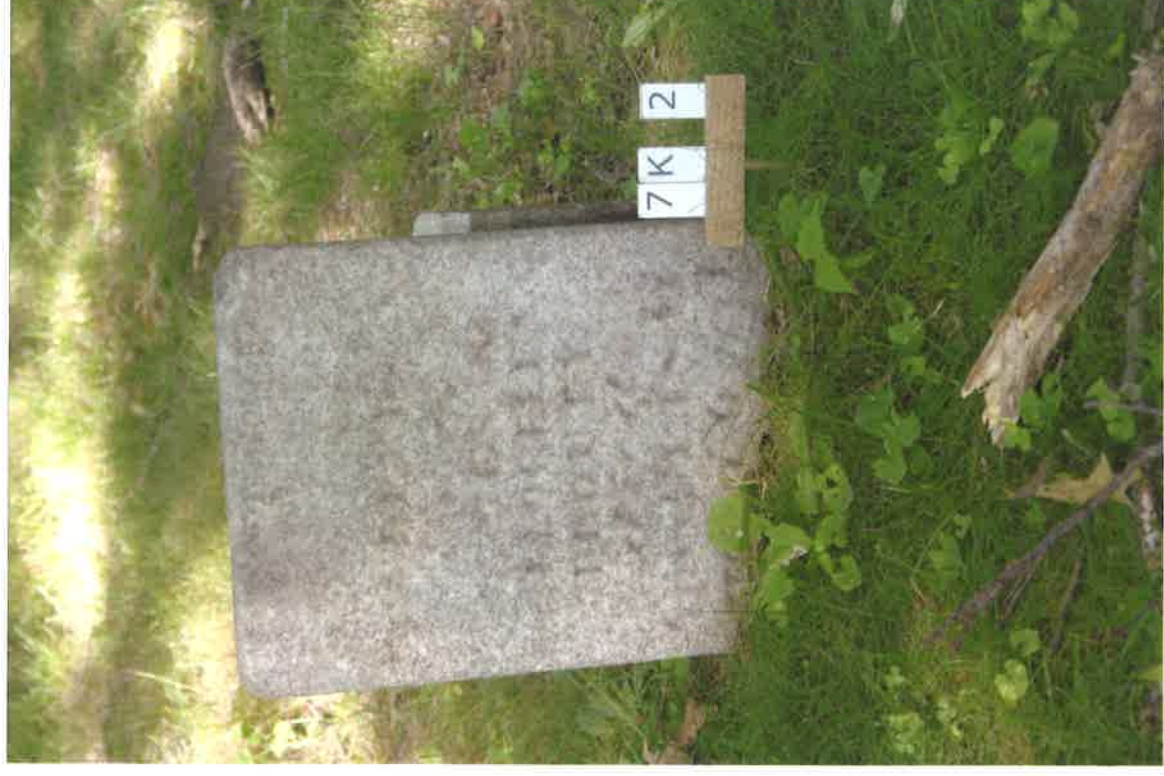
Marker# 7K.2

| <b>EXISTING CONDITIONS</b><br>Unstable | <b>CONSERVATION STRATEGY</b><br>If required, level base.<br>Reset elements with cementitious lime mortar |

1. Inspect soundness of setting joint of marker to base, if unstable, remove from base.
2. Excavate area around existing base.
3. Align base with adjacent markers and re-set level and plumb.
4. Backfill with tamped gravel and re-grade with existing topsoil
5. If setting joint was unsound, remove failed setting mortar and replace setting pins with stainless pins if necessary.
6. Prime setting surfaces with Acryl 60 diluted 1:3 with water.
7. Re-set marker plumb onto base with cementitious hi-cal lime mortar
8. Remove excess grout and brace marker until cured.

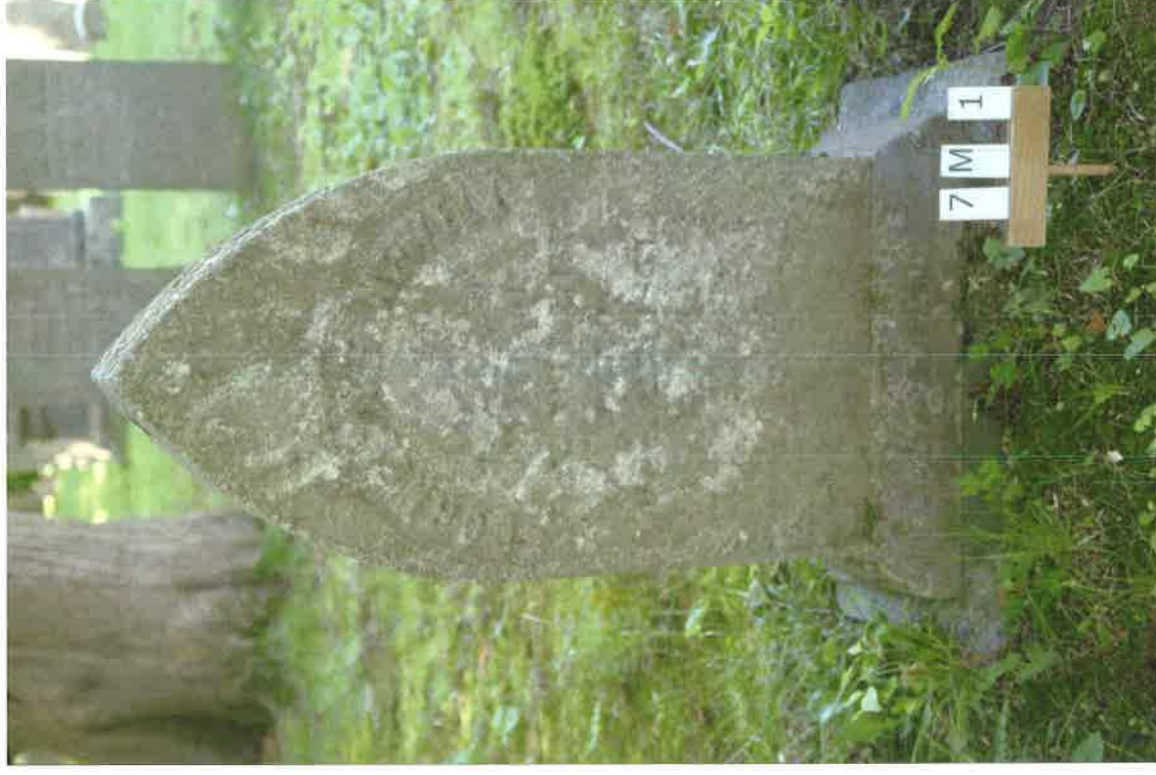
Marker# 7M.1

**EXISTING CONDITIONS** **CONSERVATION STRATEGY**  
Unstable If required, level base.  
Reset elements with cementitious lime mortar

1. Inspect soundness of setting joint of marker to base, if unstable, remove from base.
2. Excavate area around existing base.
3. Align base with adjacent markers and re-set level and plumb.
4. Backfill with tamped gravel and re-grade with existing topsoil
5. If setting joint was unsound, remove failed setting mortar and replace setting pins with stainless pins if necessary.
6. Prime setting surfaces with Acryl 60 diluted 1:3 with water.
7. Re-set marker plumb onto base with cementitious hi-cal lime mortar
8. Remove excess grout and brace marker until cured.

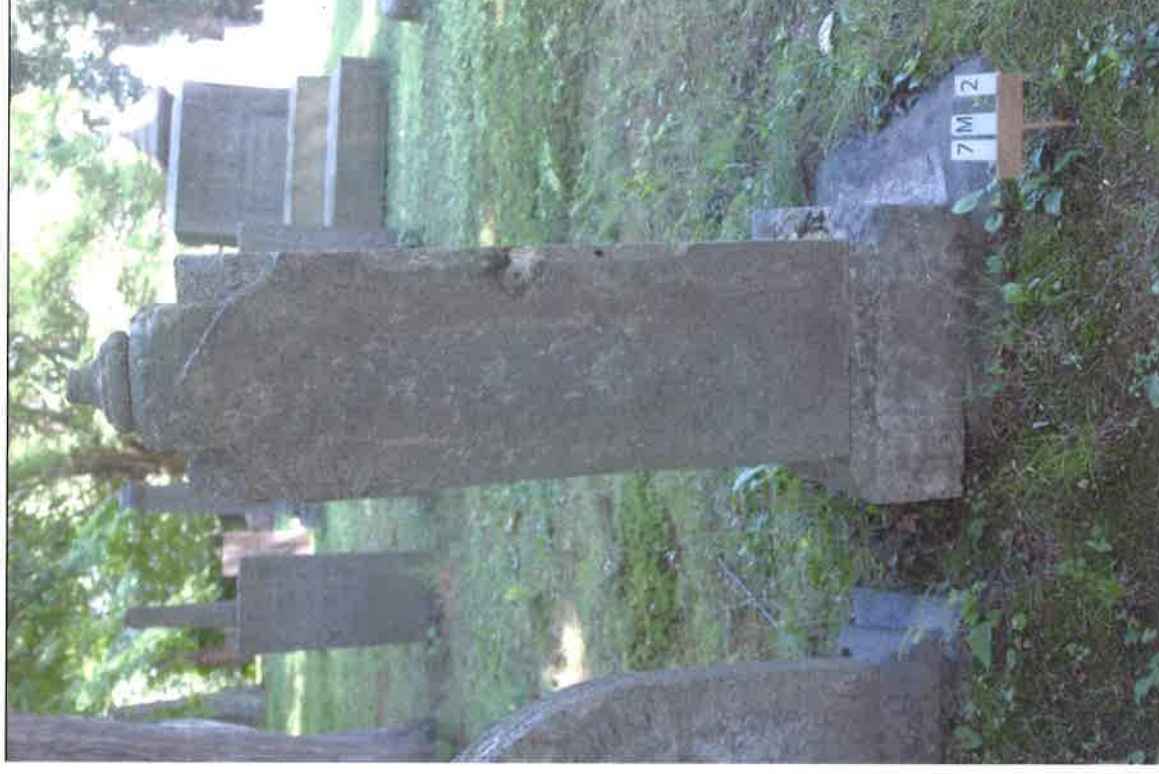
Marker# 7M.2

| <b>EXISTING CONDITIONS</b><br>Unstable<br>Bio-growth | <b>CONSERVATION STRATEGY</b><br>If required, level base.<br>Reset elements with cementitious lime mortar<br>Treat with D2 Biological solution |

1. Inspect soundness of setting joint of marker to base, if unstable, remove from base.
2. Excavate area around existing base.
3. Align base with adjacent markers and re-set level and plumb.
4. Backfill with tamped gravel and re-grade with existing topsoil
5. Treat all surfaces with D/2 biological solution and scrub with nylon brushes. Rinse fully with water.
6. If setting joint was unsound, remove failed setting mortar and replace setting pins with stainless pins if necessary.
7. Prime setting surfaces with Acryl 60 diluted 1:3 with water.
8. Re-set marker plumb onto base with cementitious hi-cal lime mortar.
9. Remove excess grout and brace marker until cured.
